PHASE I ENVIRONMENTAL SITE ASSESSMENT

Pullman Car Manufacturing Company "Pullman State Historic Site" 748 E. 111th St. Chicago, IL LPC 0316505070 ILB 000 000 135

THE OFFICE OF SITE EVALUATION
DIVISION OF REMEDIATION MANAGEMENT
ILLINOIS ENVIRONMENTAL PROTECTION AGENCY
1021 NORTH GRAND AVENUE E.
SPRINGFIELD, ILLINOIS 62794-9276

December 16, 2013

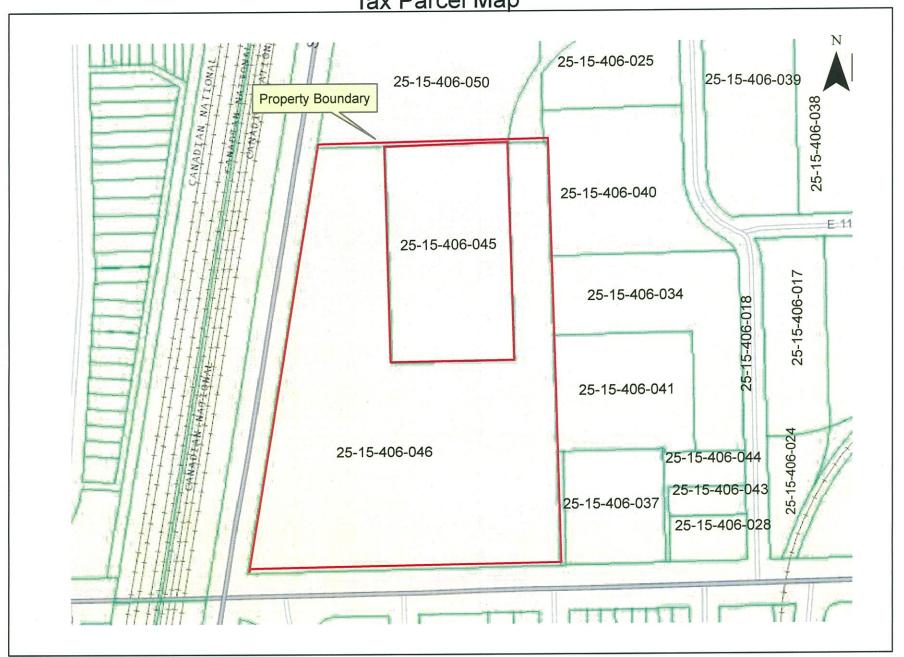
Figure 3
Regional Aerial Photo Map
Pullman Car Manufactoring Company

The subject property roughly 12.8 acres and is divided into two separate parcels with three structures currently remaining on the property (Figure – 3). The two parcels will be referred to by the last two digits of the corresponding Property Index Numbers (PINs). The northeast corner of the property (PIN 45) is overgrown with debris piles and fallen trees measuring approximately three acres. The remainder of the property (PIN 46) contains the remains of the Pullman Administrative Building, Front Erecting Shop, and the southern portion of the Rear Erecting Shop. This area measures roughly 9.7 acres. Figure - 4 is a historical map which shows the location of these structures at time of construction. In 1998, a fire caused severe damage to the Administrative Building and destroyed the 1907 South Factory Shop addition. Debris left over from the factory remains onsite as well as overgrown vegetation.

The author of this report visited the property located at 748 E. 111th Street on October 15, 2013. At the time of the visit, there were three remaining structures present on the subject property. Figure - 3 is an aerial photo which shows the location of the three structures. The northern most structure was a large building that contained the North Factory Wing and just below that was a three story building that was known as the Administrative Building with the Clock Tower. The southernmost building on the property contains remains of the Rear Assembly Shop as seen in Appendix – F, photos 1 and 2.
